# 2005 Case Histories two thousand-five

## Construction Disaster Averted With APL & Nu Flow

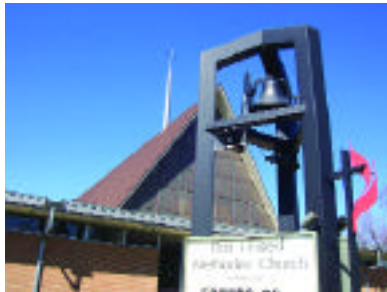
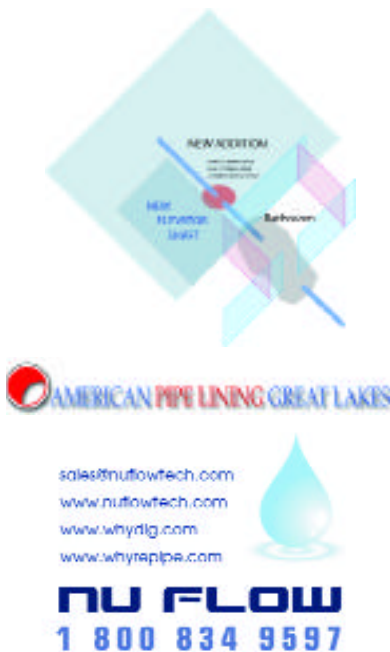
As the First Methodist Church of Garden City, Mich., eagerly anticipated the new addition to its building, especially the elevator to allow unobstructed access to its Fellowship Hall for the members and friends unable to navigate the stairs, an issue developed with a 6-inch combined storm-sanitary line that had been unknowingly broken during the excavating of the elevator footings. The collapsed pipe was not identified until the construction company had completed the roughing in of the new addition, which was directly over the broken sanitary line. The break in the sanitary pipe subsequently shut down the use of the building's kitchen and basement bathrooms. The diagnostic work by American Pipe Lining — Great Lakes (APL-GL), based in Livonia, Mich., revealed that the broken pipe was collapsed approximately 17 feet from a cleanout access located in the basement men's bathroom. The extent of the collapse (length and/or number of breaks) could not be determined by CCTV. APL-GL offered an exploratory procedure to the contractor, not to

After excavating an access pit in the men's bathroom, APL-GL, using a low-pressure jetter, Vactron, CCTV and fabricated tools, was able to clear the collapsed clay pipe and infiltrated dirt. The removal of the collapsed pipe revealed a 30-inch void in the sanitary line. APL-GL determined the pipe could be repaired.

Nu Flow's CIPP (cured in place pipe) technology and tools allowed APL-GL to repair the break by using a 4-ft.-long stint of NuFlex CIPP to span the void. Using a push rod and CCTV, the stint was maneuvered into place where it was inflated and cured. After successfully repairing the break, the entire combined sanitary-storm pipe was then restored with a 66-ft. liner, renewing the pipe from the cleanout to the city sewer. The church now has its kitchen, bathrooms and storm sewer back online, and the construction company avoided any demolition of the completed new construction to repair the break. The total APL-GL working time was five days.
